Dead Pike Lake Management Plan Vilas County, Wisconsin

April 13, 2018 Updated November 2018

Pete Guzzetta, Gale Wolf and Kathryn Wolf Dead Pike Lake Association

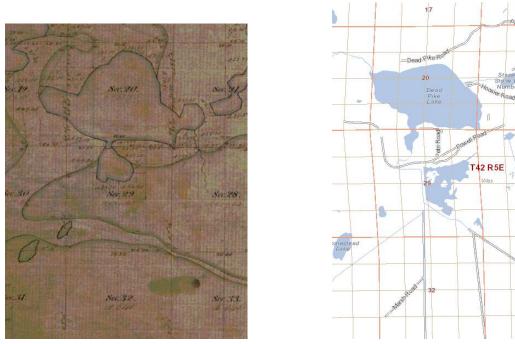
Figure 4. 1860 Original Government Survey and Present-day Surface Water Map. Dead Pike Lake and Powell Marsh area from 1860 (left) Original Government Survey (BCPL, 2018) and present-day surface water features (right) mapped in Department of Natural Resources Surface Water Data Viewer (WDNR, Surface Water Data Viewer, 2018a)

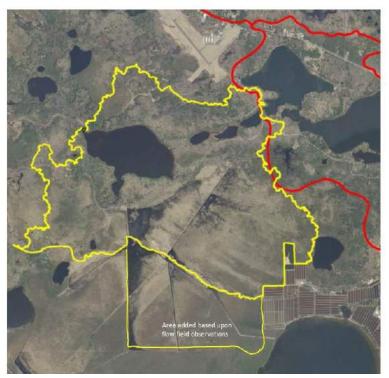
Figure 6. Dead Pike Lake Watershed Area

Watershed area delineated with PRESTO (WDNR, 2013) using Vilas County lidar elevation data and ground truthing in the field.

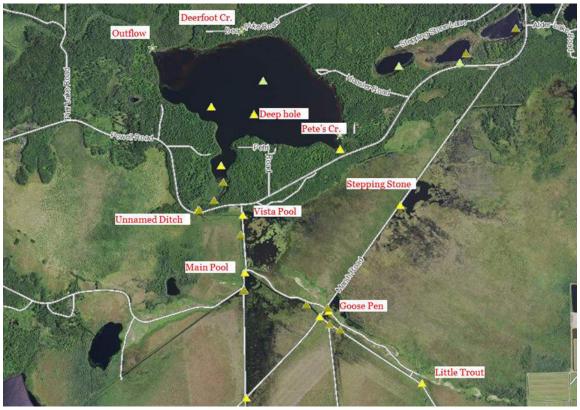
Figure 12. Surface Water Chemistry Monitoring Sites Location of bi-weekly, surface water chemistry and flow monitoring locations at Dead Pike Lake and Powell Marsh State Wildlife Area.

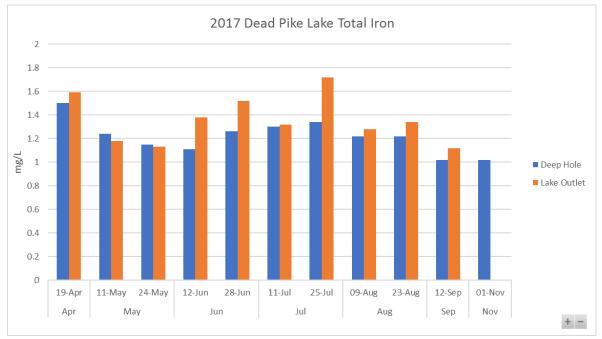
Figure 22. 2017 Dead Pike Lake Total Iron Concentrations 2017 Dead Pike Lake total iron concentrations at the deep hole and the lake outlet.
